# Inspection Report

**Date:** 4/9/2013

**Report ID:** 130409B

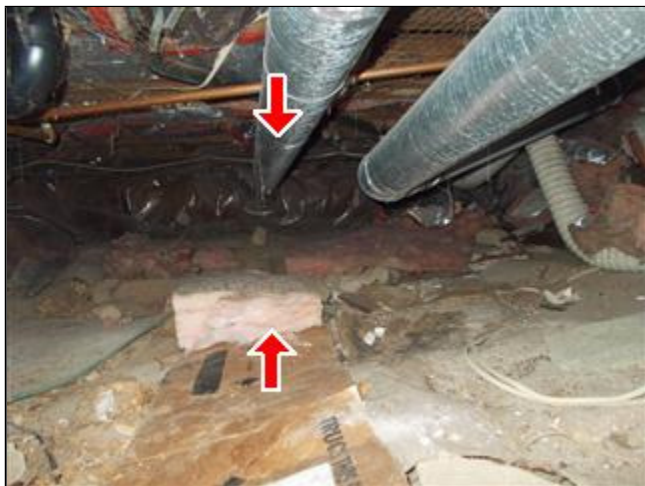
1.0 Picture 1

(2) There were many inaccessible areas encountered at crawlspace in my attempt to complete the structural inspection of this building. Obstructions to adequate access were , but not limited to inadequate height. If obstructions are removed, and you are interested in a re-inspection of those areas at additional cost, please contact me to arrange.

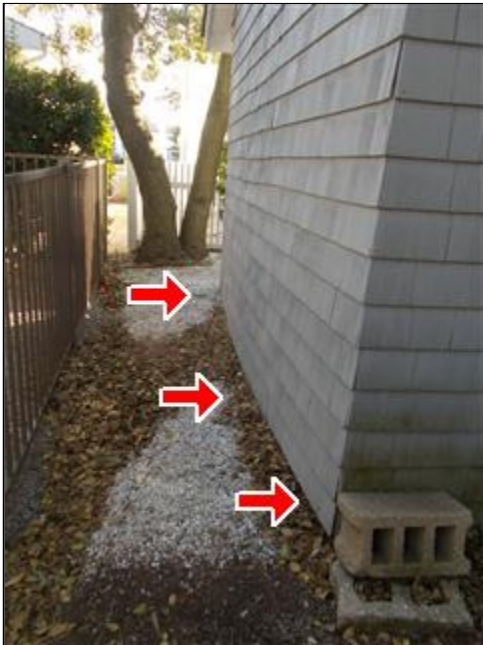
- (1) The walls in this building are constructed of conventional 2x4 stud framing.
- (2) Most walls are covered with finish materials and so are not accessible for complete inspection. While no obvious deficiencies were observed on the date of inspection, adequate construction practices or possible existing deterioration can not be readily seen or evaluated.
- (3) Excessive bowing or deflection of vertical wall surfaces from plumb were not observed in the exposed and accessible areas of the structure.
- (4) Walls at garage rear wall are deteriorated by impact damage and are bowed in and will require replacement and repairs as required.

1.2 Picture 1 rear wall of garage bowed out

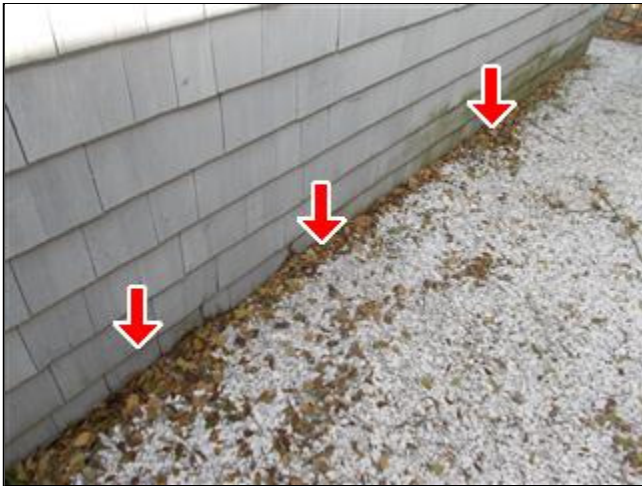
2.1 Picture 2

(3) Siding in contact with ground at garage left side (facing front) and right side (facing front). Recommend a ground clearance of six to eight inches where possible.

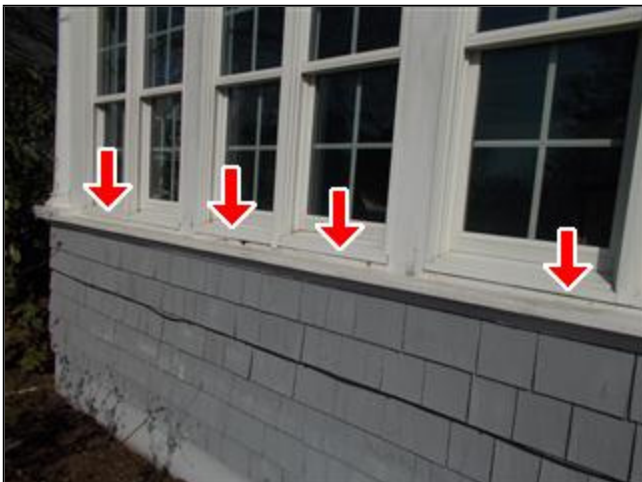
2.3 Picture 1

Window frame and Wood trim are deteriorated and weathered and needs repair or replacement at right side (facing front) at some windows.

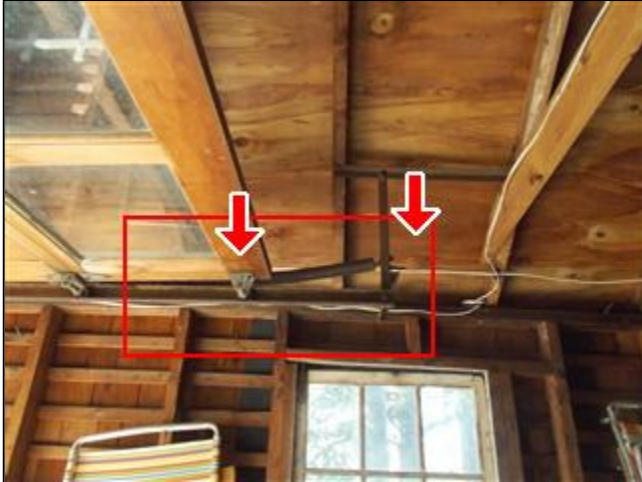
2.4 Picture 1

(2) The garage door operators are older and do not contain sensors for reversing of door(s).

(4) Spring safeties are not installed but should be to help prevent hazardous conditions if spring should fail or break and cause bodily harm or damage to structure. These retaining wires are threaded through the springs and attached to tracks or hanger hardware and repair should be performed by a professional.

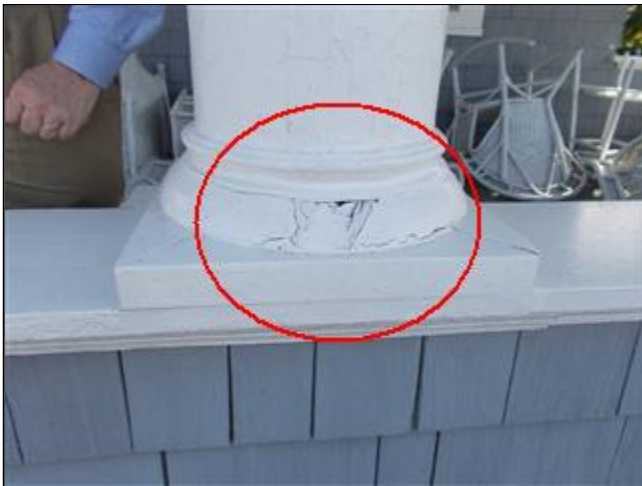
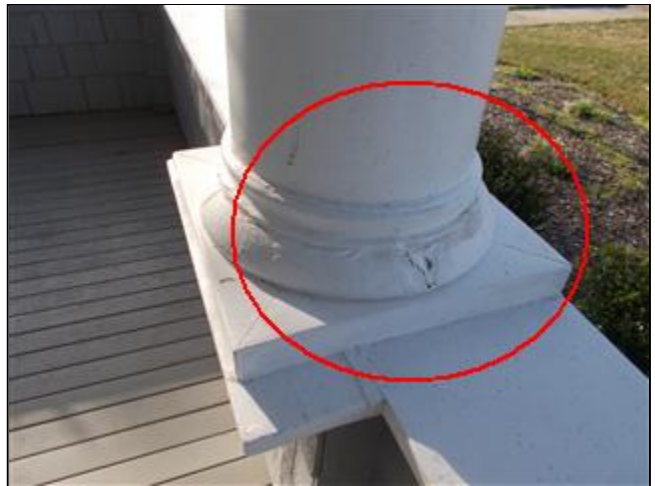
2.5 Picture 1

Wood column (s) on entry Porch at front of home are deteriorating at column base plate. Needs repair to preserve or replace

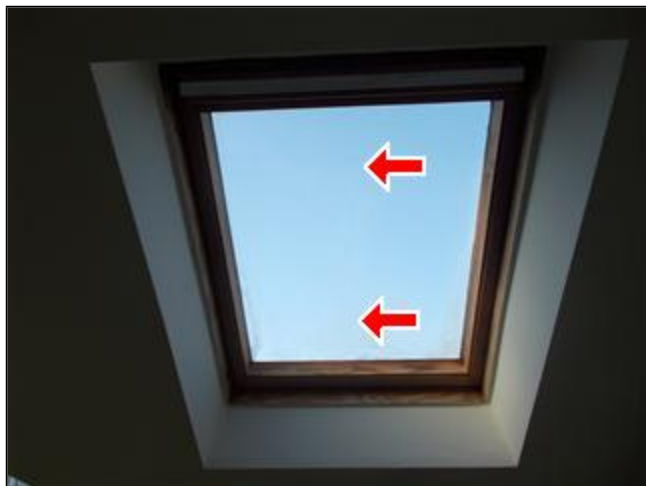
3.2 Picture 1

(1) One Skylight is cloudy, (lost seal) at master bedroom. Replace insulated glass unit.

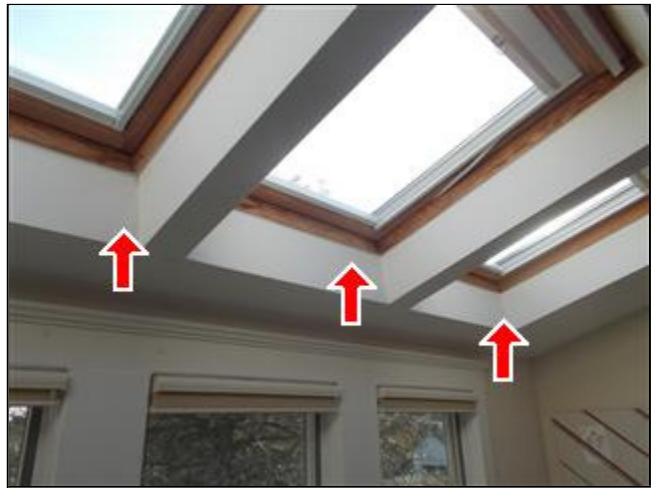
(2) Three Skylights has stains indicating a leak did or does exist at guest bedroom (South side of home).

3.2 Picture 2 water stains

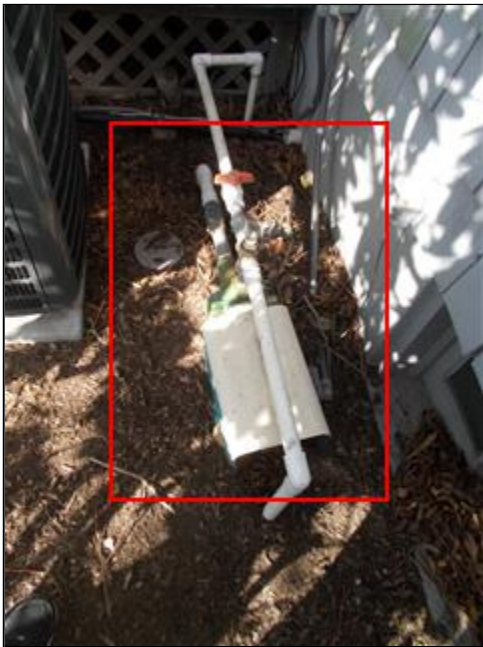
4.1 Picture 1

(3) There is a well system installed on property for irrigation/sprinkler system. Such systems are not included as part of this inspection and should be separately evaluated by a qualified professional for proper operating condition.

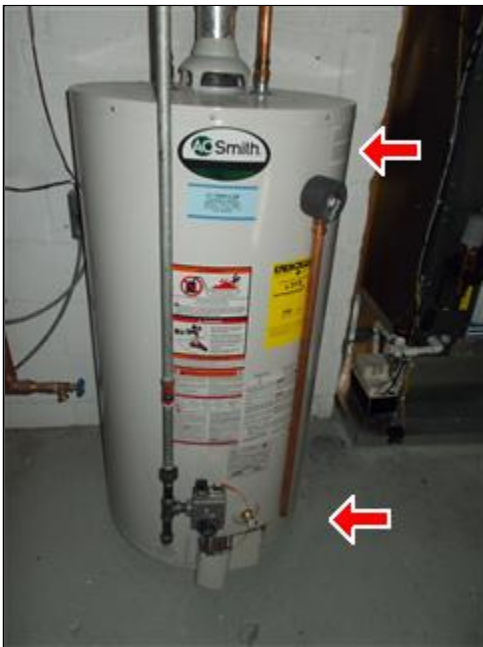
4.2 Picture 1

Water heater is roughly 3-4 years old, which is early in its useful life. Water heaters of this type generally last from 8-12 years. No action required at this time.

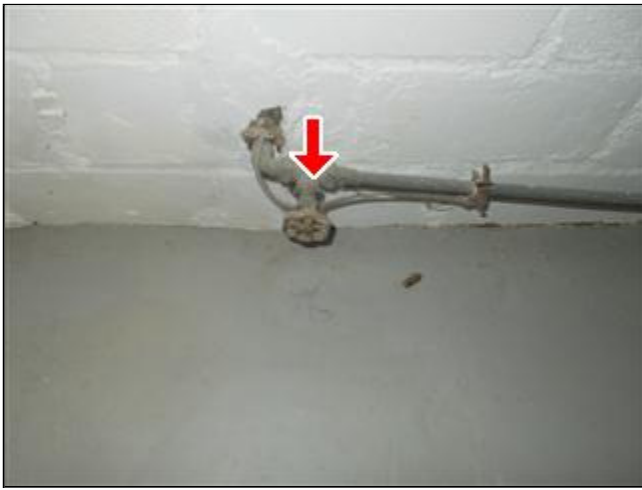
4.3 Picture 1

The main shut-off is the red knob at water meter in basement (For your info).

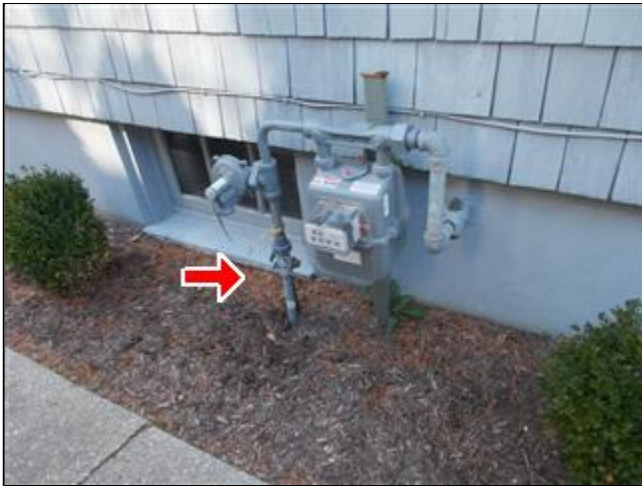
4.4 Picture 1

(1) Main gas shutoff valve is located at exterior left side of building.

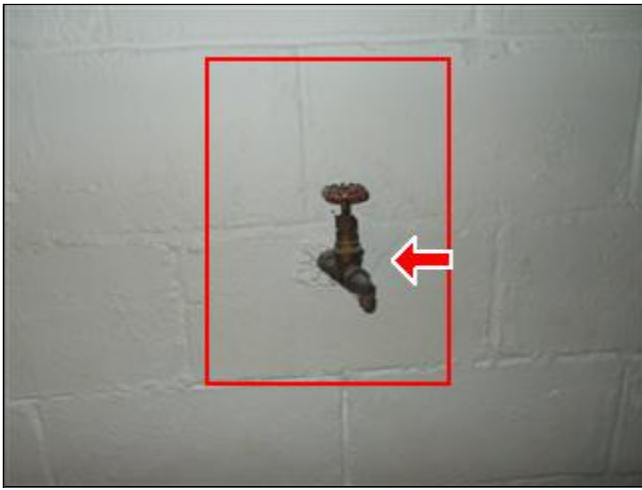
(2) BURIED FUEL OIL STORAGE TANK- There are indications that a buried fuel oil storage tank may be or may have been buried on this property. We do not test for the existence or condition of these items. You should contact a tank remediation or testing company of your choice to determine if , in fact a tank is present, whether it has leaked or may have contaminated the soil around it or if it needs to be removed. For tanks that are still in service, they must be certified and tested by the tank specialist to determine whether suitable for further use.

4.4 Picture 2 possible oil fill line from buried oil storage tank

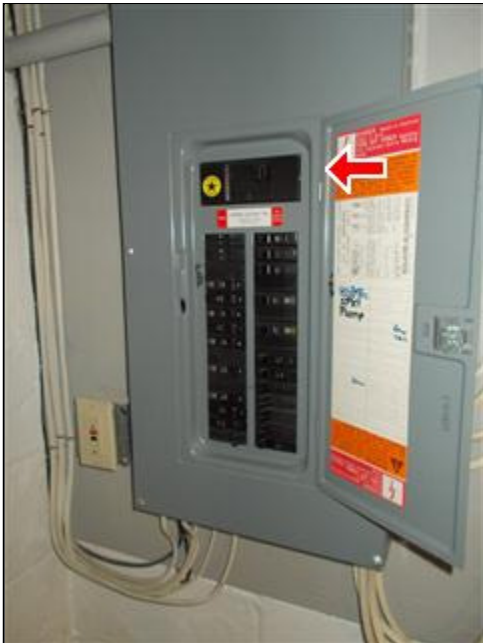
5.1 Picture 1

(1) Main panel is circuit breakers located on wall of basement. Main disconnect and shutoff is located inside panel above breakers

(2) Problem(s) discovered in panel such as Panel is overloaded, service panel is full, no room for expansion of system and any other problems that an electrician may discover while performing repairs need correcting. Recommend a licensed electrician inspect further and correct as needed.

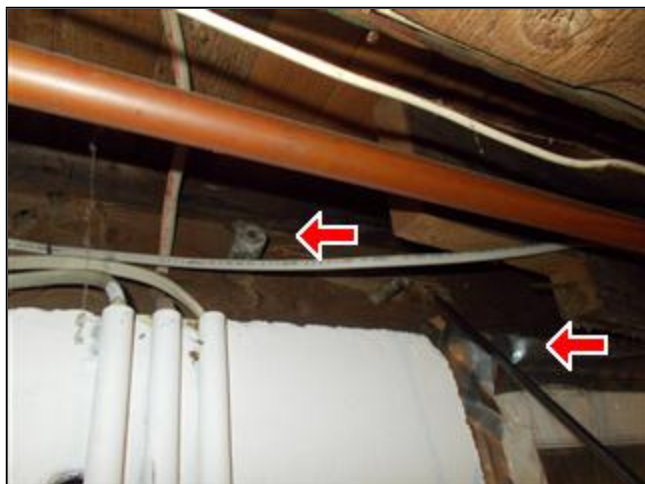
5.2 Picture 1

Wiring problems such as knob and tube wiring, open and exposed conductors, surface run Romex wiring, cloth jacketed old wiring found at basement, attic ceiling. Further investigation and repair required by electrician. All exposed electrical wiring should be protected inside an approved electrical conduit.

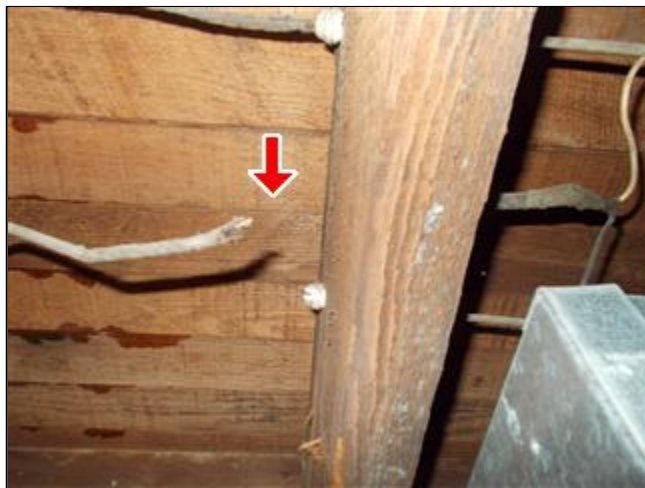
5.2 Picture 3 broken k+t wire conductor.

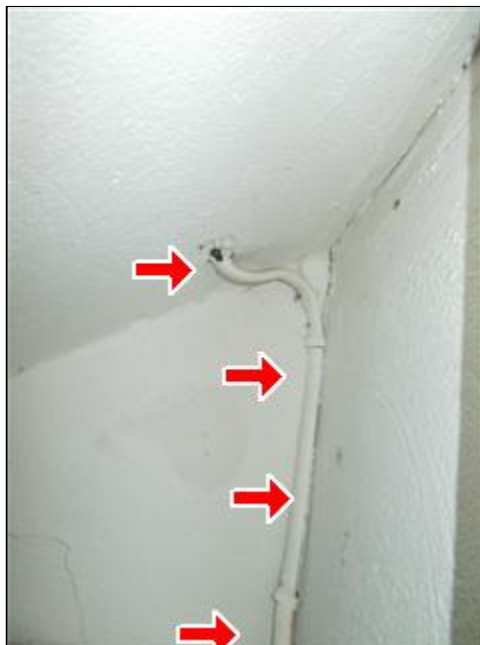
5.2 Picture 4 surface run wiring in upstairs bedroom closet

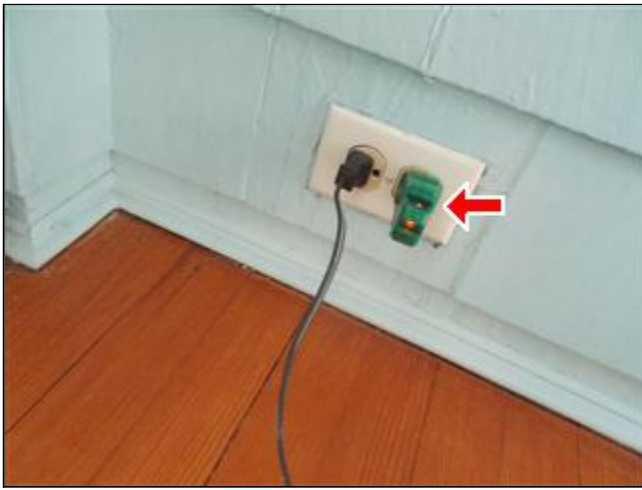
- (1) Recommend a licensed electrician correct all electrical defects found.
- (2) A random number of light fixtures, outlets, etc. were operated and found to be generally adequate. We do not test every fixture on a typical inspection.
- (3) Several "Three-prong" outlets are not grounded. Needs correcting at various locations throughout.

5.3 Picture 1 open ground

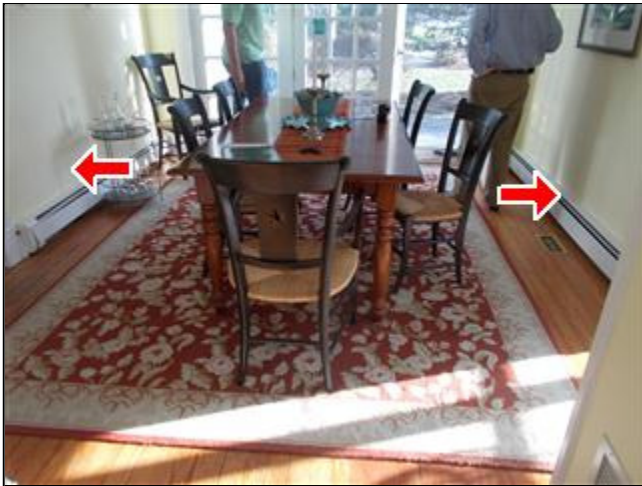
(4) (Picture 1) "Three-prong" outlets are missing or inadequate number or none installed at Dining Room and various locations throughout.

5.3 Picture 2 no outlets in this room

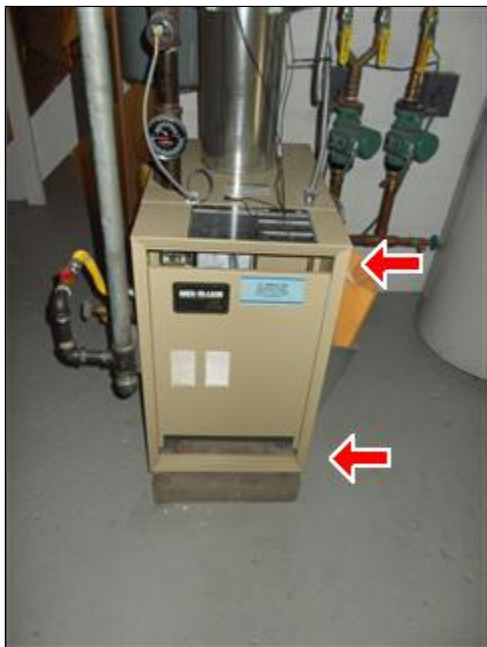
6.0 Picture 1

(1) The heating system in this building is gas fired boiler which appears to be newer replacement installation 1-5 yrs old early in its useful life. No action required at this time. All heating systems require seasonal maintenance , lubrication, cleaning, filter changes, etc. and this system should be regularly serviced to keep at optimum efficiency.

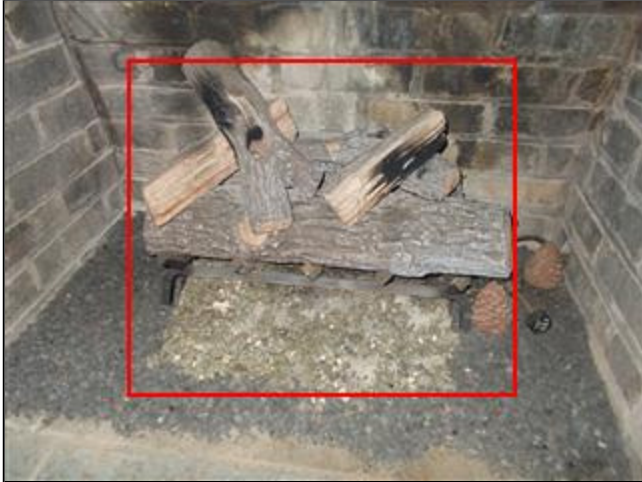
6.4 Picture 1

Gas logs not operated or tested on the date of inspection. You should verify that this system is in adequate working condition prior to purchase.

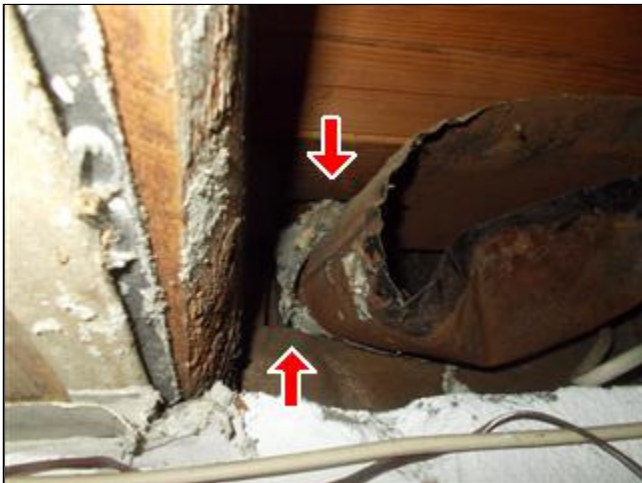
6.5 Picture 1

(2) Supply ductpipe is possibly asbestos wrapped in basement overhead.

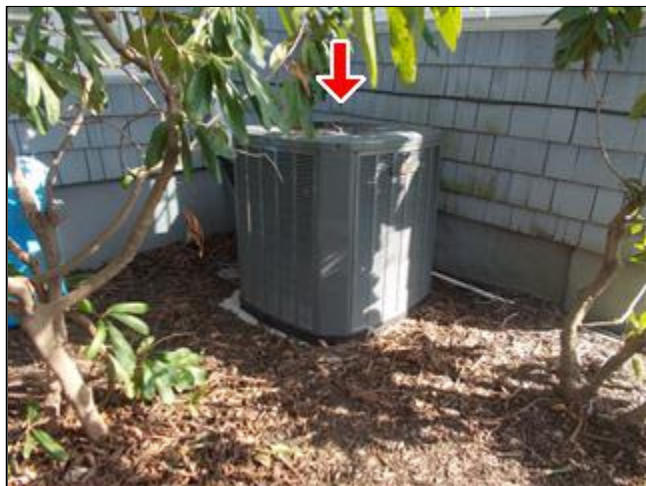
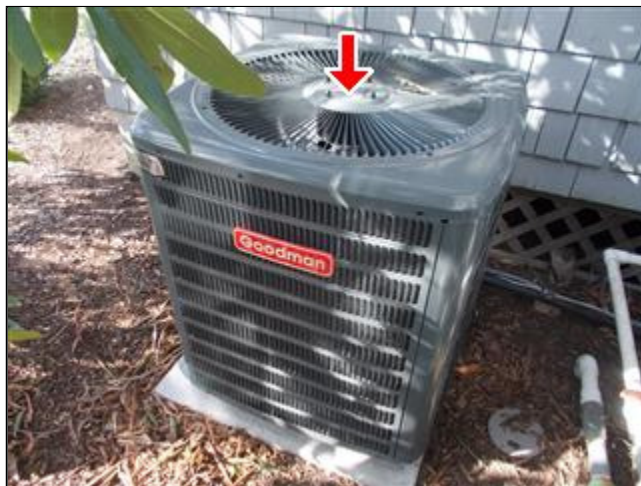
(2) The condensing unit is approximately 1-5 years old newer installation at beginning of useful life A/C units generally last and are rated for an approximate 15 year average service life. This does not mean that they are guaranteed by the manufacturer to last this long. Factors which affect longevity would be regular maintenance and cleaning practices, adequate airflow, protection from elements in the off season, etc. The unit will require normal annual maintenance and checkup by an A/C technician to insure long life and adequate operation.

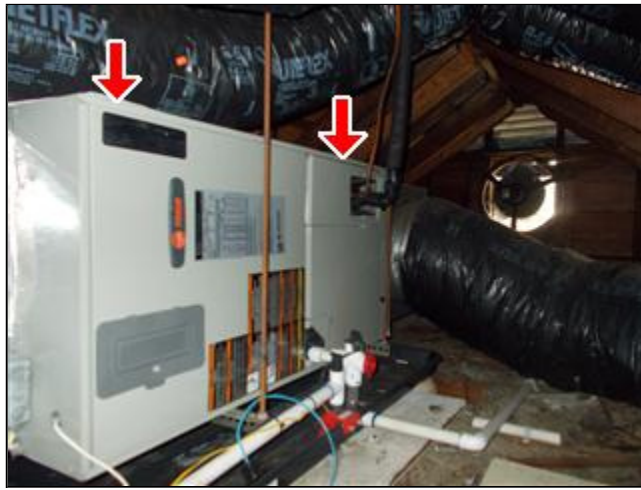
(3) The part of the A/C system inside the home is the air handler which contains the cooling coil and blower fan which distributes cooled air through the ducting system throughout the home.

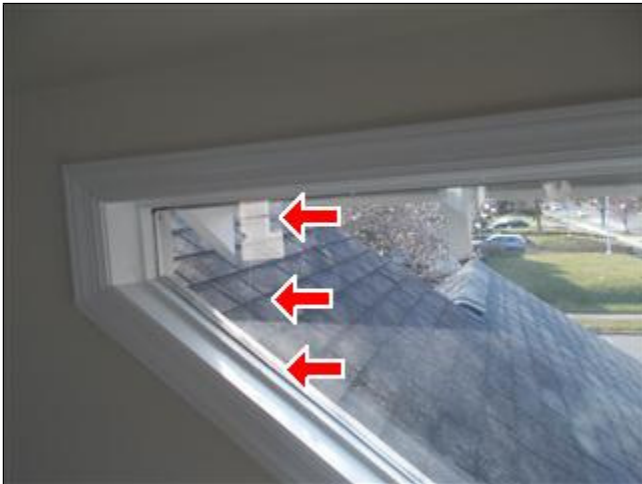
8.6 Picture 1

(2) One window is cracked at glass pane at Master Bedroom.

Replace all broken panes or insulated window units .

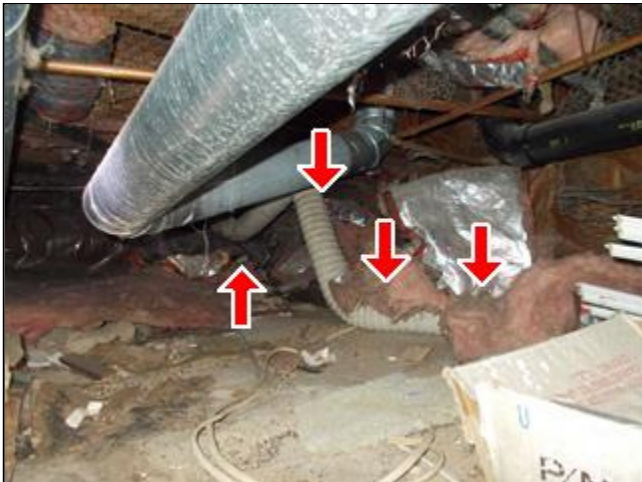
9.2 Picture 1

Dryer vent piping is loose in crawlspace. Recommend metal flex or rigid pipe when repaired Also, is plastic vinyl and is not allowed when dryer is powered by gas/propane. Recommend changing to metal flex.

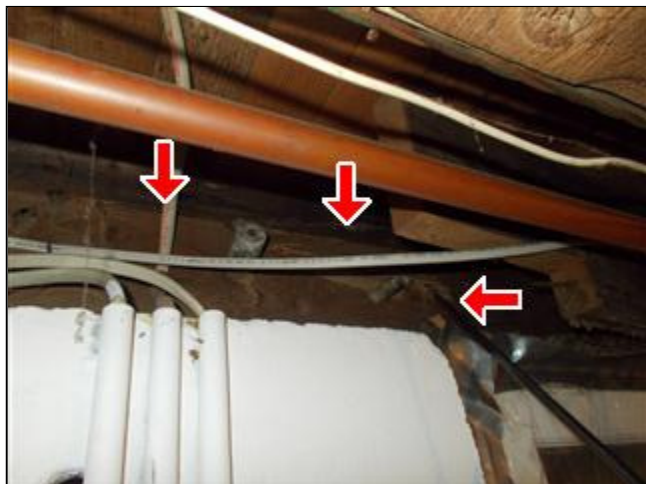
- (1) This report is indicative of the condition of the subject structure(s) ON THE DATE OF INSPECTION ONLY and is NOT to be construed as an express or implied warranty against latent, concealed, or future infestation or defects.
- (2) Based on a careful visual inspection of the readily accessible areas of the structure(s), there is visible evidence in the form of EXIT HOLES and DAMAGE of SUBTERRANEAN TERMITES at BAND JOIST, SILL PLATE, WOOD TRIM JOIST in LEFT SIDE (facing front of building) and REAR BASEMENT.

11.1 Picture 1 termite damage at rear of basement

- (3) The accessible ,inspected areas observed appear to be ACTIVE. Treatment recommended at this time..
- (4) CONDUCTIVE CONDITIONS EXIST!- There are factors present which the inspector feels could lead to further pest infestation or concealed infestation which may be currently taking place, such as earth-wood contact or proximity, insufficient ventilation, moisture. Steps should be taken to remove or remediate these conditions to reduce the chance of further wood destroying insect infestation.

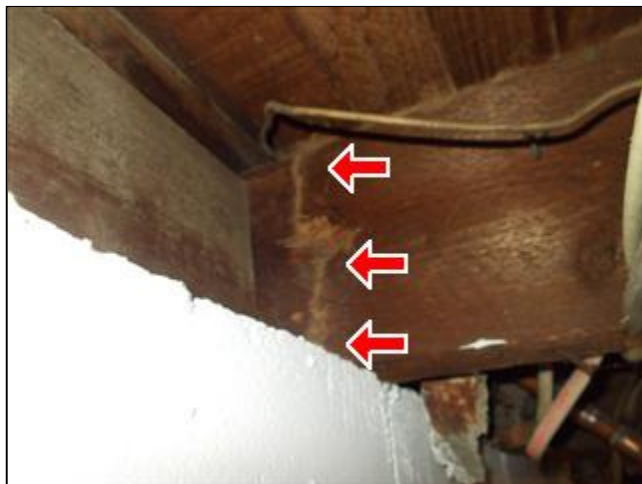
11.1 Picture 2 termite evidence in floor joist
